# Manhole Inspection Summary

Manhole # S45E\_\_069MH

Insp Date: **7/23/08 8:57 AM**

**Location** Address: **1745 E Lombard St**

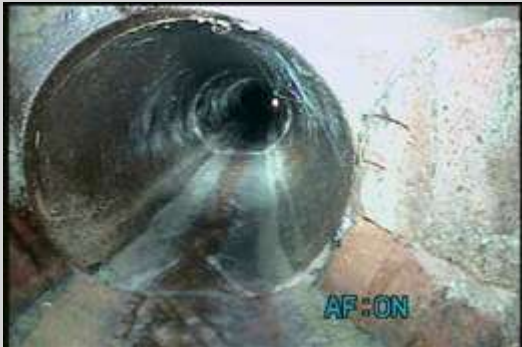
12 O'Clock Outflow

8 in. Circular Gravity Sewer  
Pipe Out @ 12 O'Clock

Pipe Height: 0 (in.) Direct

Pipe Material: **Clay** ☐ Pipe Lined

Invert Depth: **12.73** (ft.) Flow Characteristics: **Fast**

Deposits: ☒ None ☐ Mud ☐ Sludge ☐ Debris ☐ Grease

Infiltration: **None** Pipe Seal Cond: **Unknown**

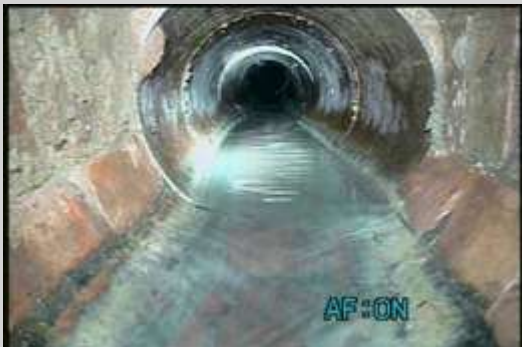
4 O'Clock Inflow

8 in. Circular Gravity Sewer  
Pipe In @ 4 O'Clock

Pipe Height: 0 (in.) Direct

Pipe Material: **Clay** ☐ Pipe Lined

Invert Depth: **12.48** (ft.) Flow Characteristics: **Fast**

Deposits: ☒ None ☐ Mud ☐ Sludge ☐ Debris ☐ Grease

Infiltration: **None** Pipe Seal Cond: **Unknown**

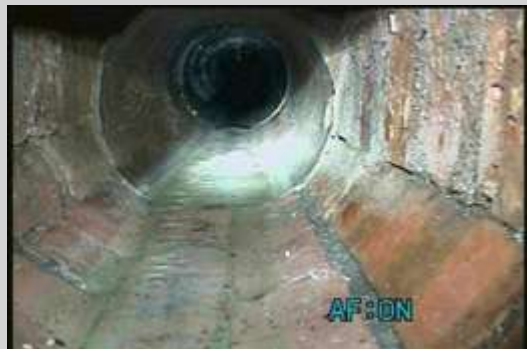
6 O'Clock Inflow

6 in. Circular Gravity Sewer  
Pipe In @ 6 O'Clock

Pipe Height: **0** (in.) Direct

Pipe Material: **Clay** ☐ Pipe Lined

Infiltration: **None** Pipe Seal Cond: **Unknown**
